## FIELD INSPECTION REPORT

<b>Project Name:</b>	Mountain Valley Pipeline	<b>Inspector:</b>	Matthew Grant
<b>Inspection Date:</b>	Monday, September 14, 2020	<b>Project Contact:</b>	Brian Clauto
<b>Spread H: Montgomery</b>	MP 230.6-231.6 MP 232.7-234.1 AR MN274, MN275, 276.03 ATWS 703, 704, 1146, 1375	<b>Weather:</b>	Dry

## FIELD INSPECTION PHOTO LOG

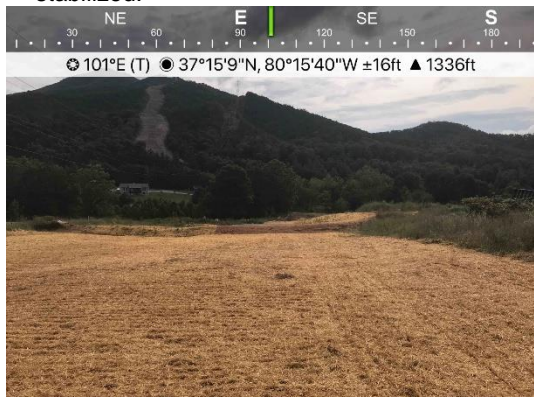
- Figure 1: Area near MP 230.6 has recently been re stabilized.

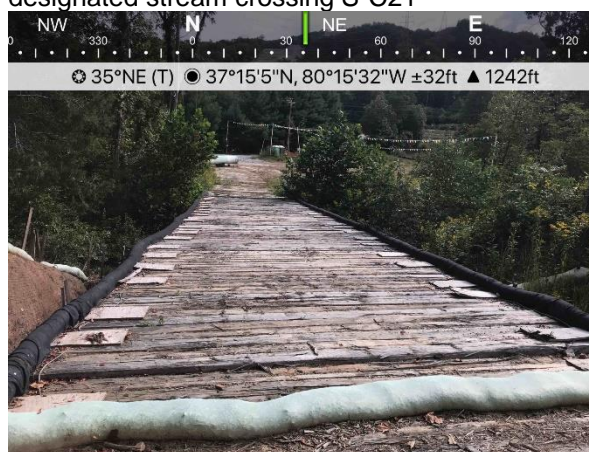
- Figure 2: Controls are in place and functioning at designated stream crossing S-C21

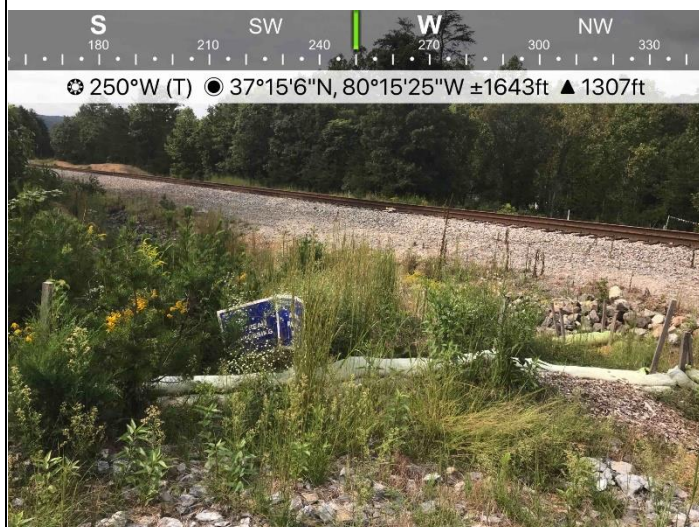
- Figure 3: Controls are in place and functioning at designated stream crossing S-001.

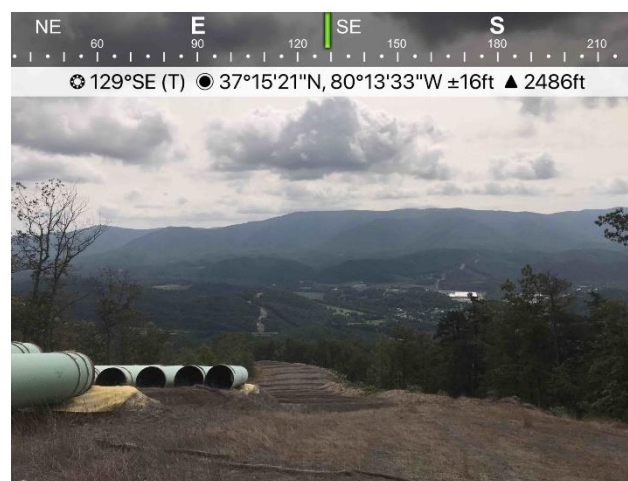
- Figure 4: Blanket matting stabilization is in place near MP 232.7
